RE: CATHODIC PROTECTION SURVEY
SCC SULFURIC ACID PLANT
2024 RECOMMENDATIONS

SCC Sulfuric Acid Plant
2024 Cathodic Protection Survey

Effectiveness of Underground Cathodic Protection

CATHODIC PROTECTION SURVEY
MAY 2024

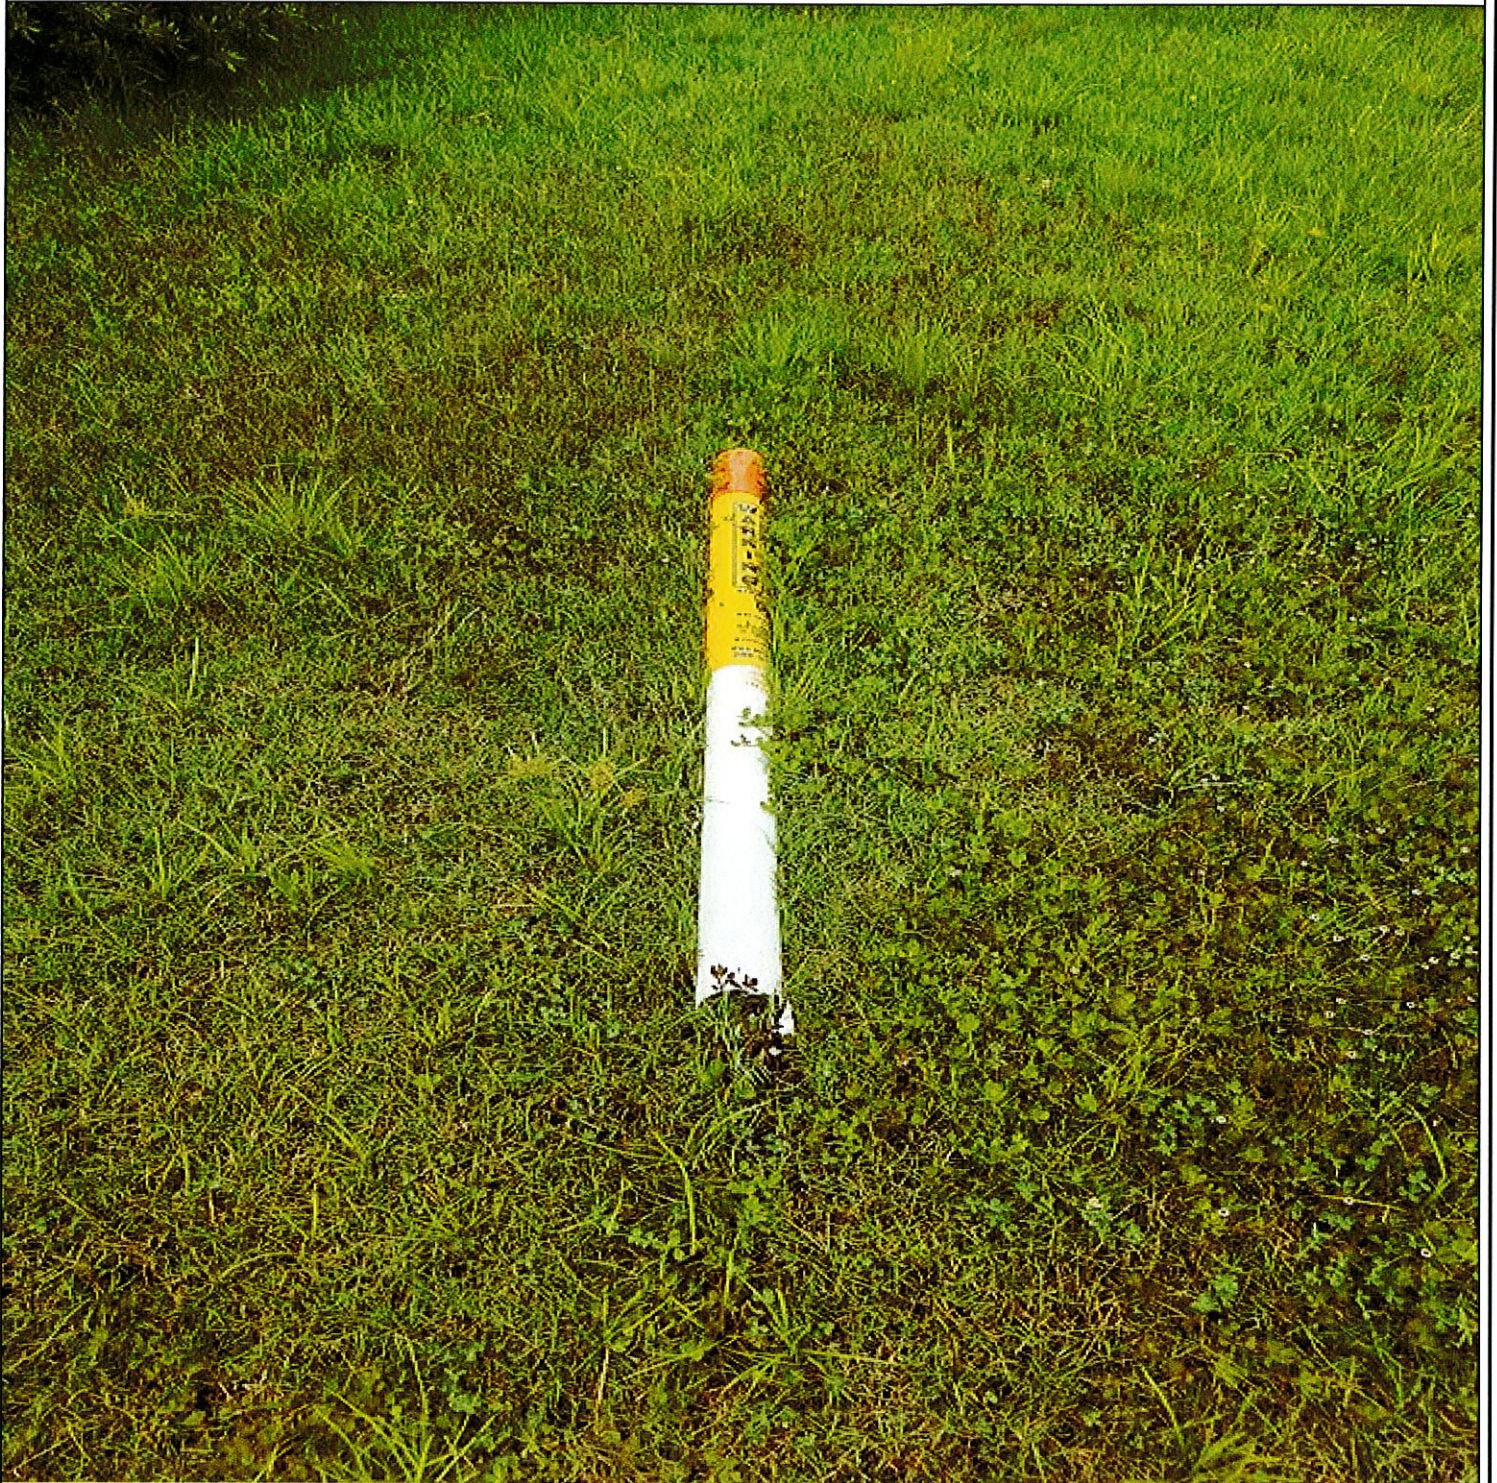
- Obtained cathodic protection measurements indicate approximately 100% of the steel gas system piping components currently meet or exceed the minimum CP requirements required by State and Federal regulatory agencies.
- No structure-to-soil readings were obtained from the single cathodic test point due to the destruction of the only CTP (see attached photo) on this system. Recommend replacing this CTP.

A total of One [1] structure reading and Zero [0] anode readings were taken during this survey. As can be seen by the structure-to-soil potential measurements and the enclosed data sheet, the structure-to-soil pipeline reading obtained at the 8" gas Riser is indicative of cathodic protection. A structure-to-soil potential of 850 millivolts [-0.850] or more negative direct current is the basis used in this report to confirm cathodic protection. The green anode connection, green gas pipeline connection and green/black gas pipeline connection were found destroyed and unusable.

CATHODIC TEST POINT FOUND DESTROYED
SEE EXHIBIT A ON PAGE 5

At this time, the Natural Gas Distribution System for Nutrien Ltd. SCC Sulfuric Acid Plant complex indicates cathodic protection levels exceeding State and Federal minimum guidelines for applied cathodic protection. The single distribution main Cathodic Test Point requires replacement to obtain future readings as required. I trust the above information to be satisfactory and in sufficient detail, however, should you require additional information, please contact me.
